Historic Structures Report
Architectural & Historical Data Section

Clubhouse, Brown Cottage, Moorhead Cottage,
and Clubhouse Annex

**SOUTH FORK FISHING
& HUNTING CLUB**

By
Landmarks Design Associates, Architects
and
Wallace, Roberts & Todd

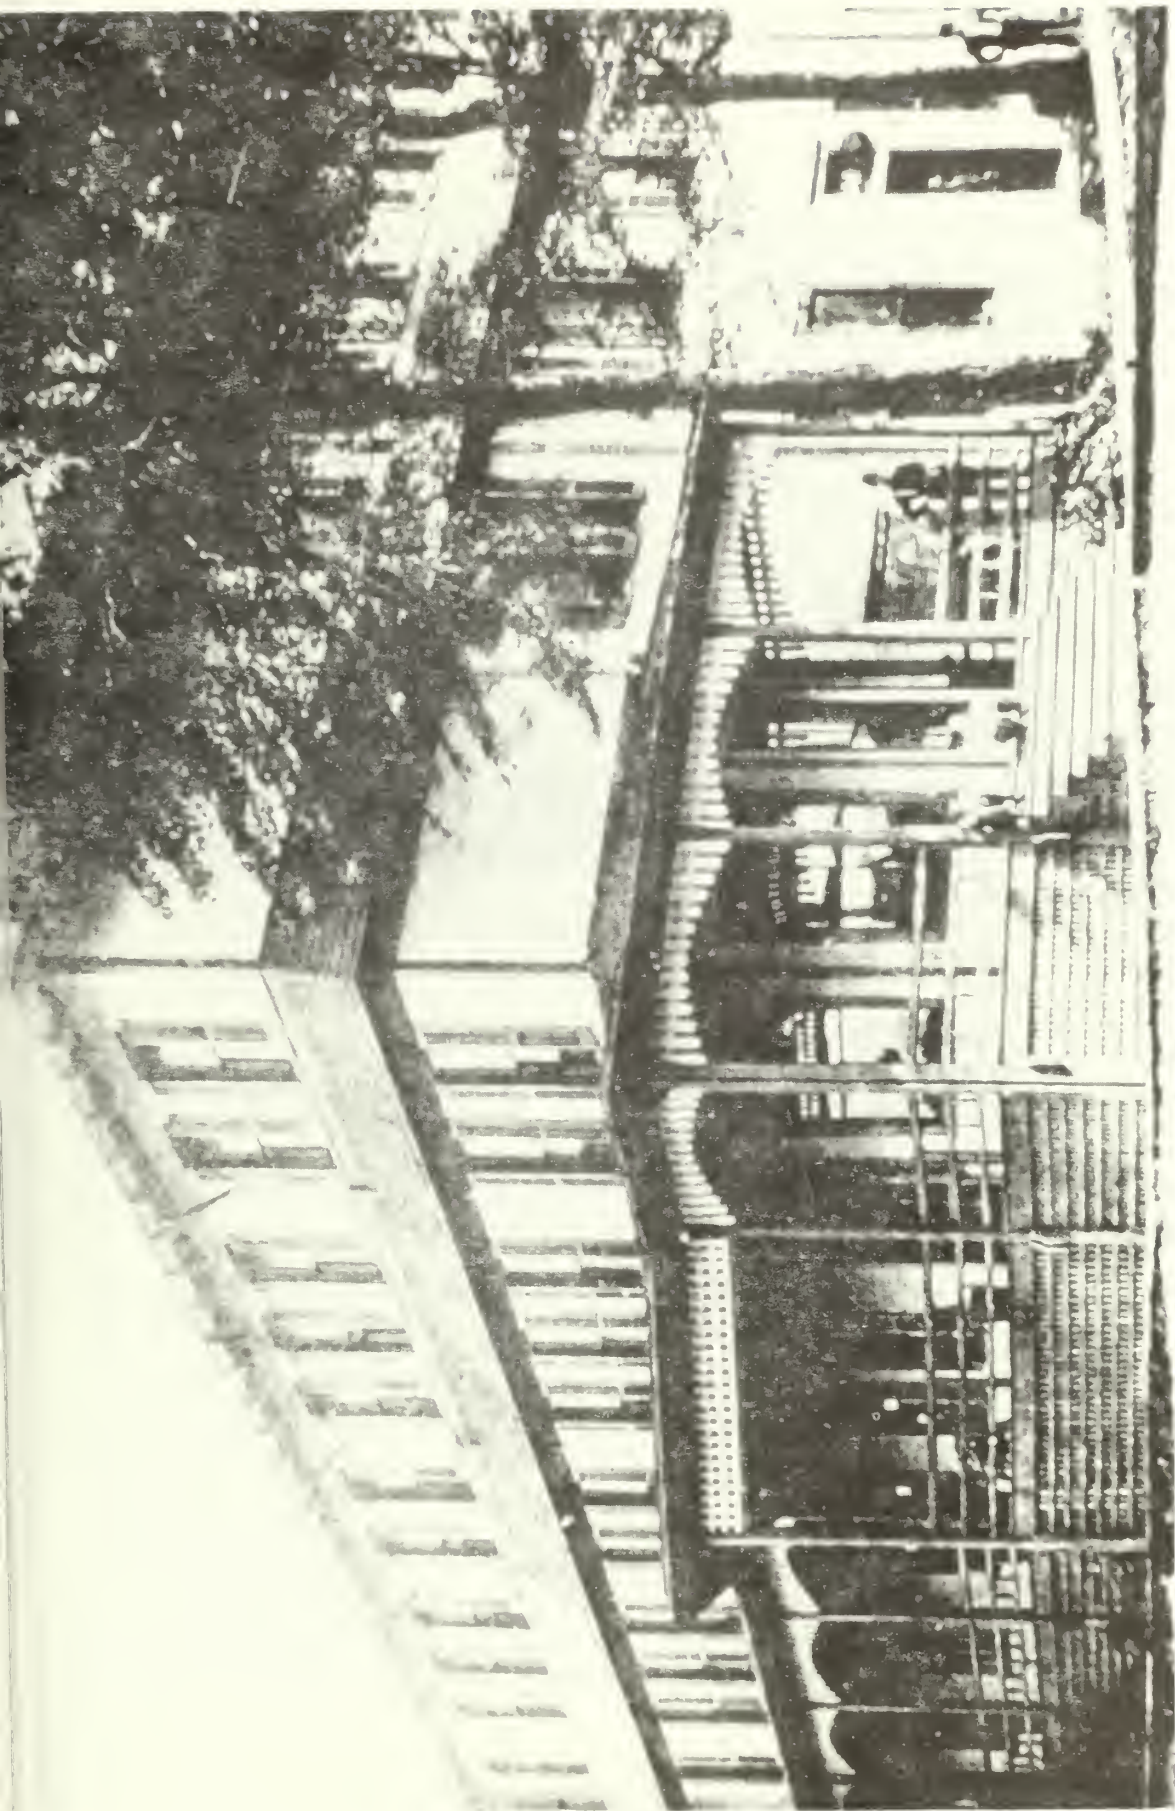
Photo E-9 View of east and south elevations.
Clubhouse 1992

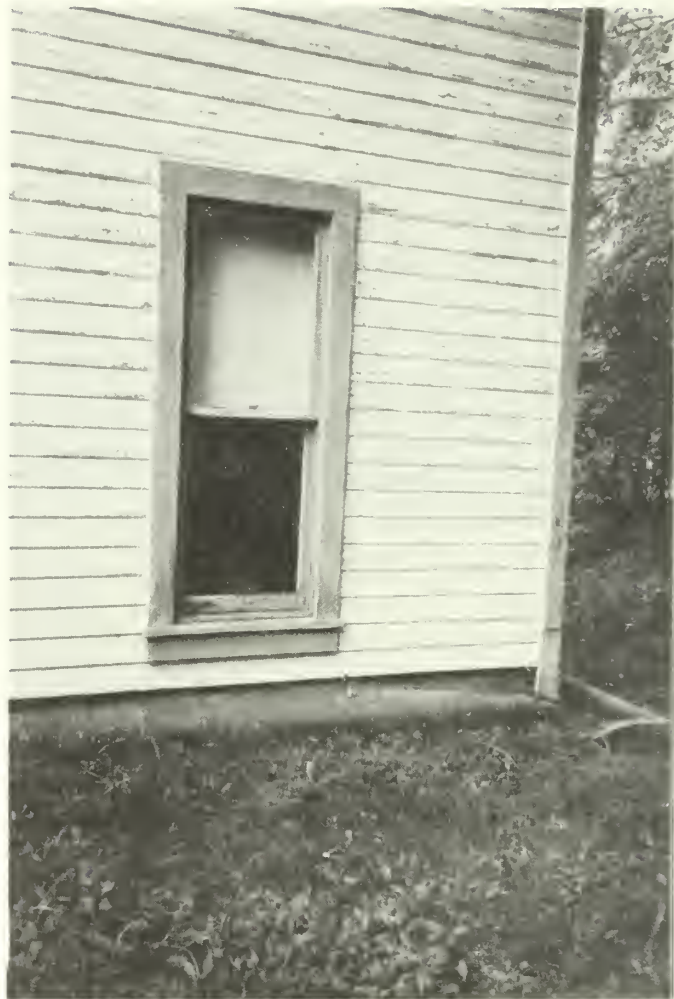
Photo E-36 View of west wall and concrete foundation.
Brown Cottage 1992

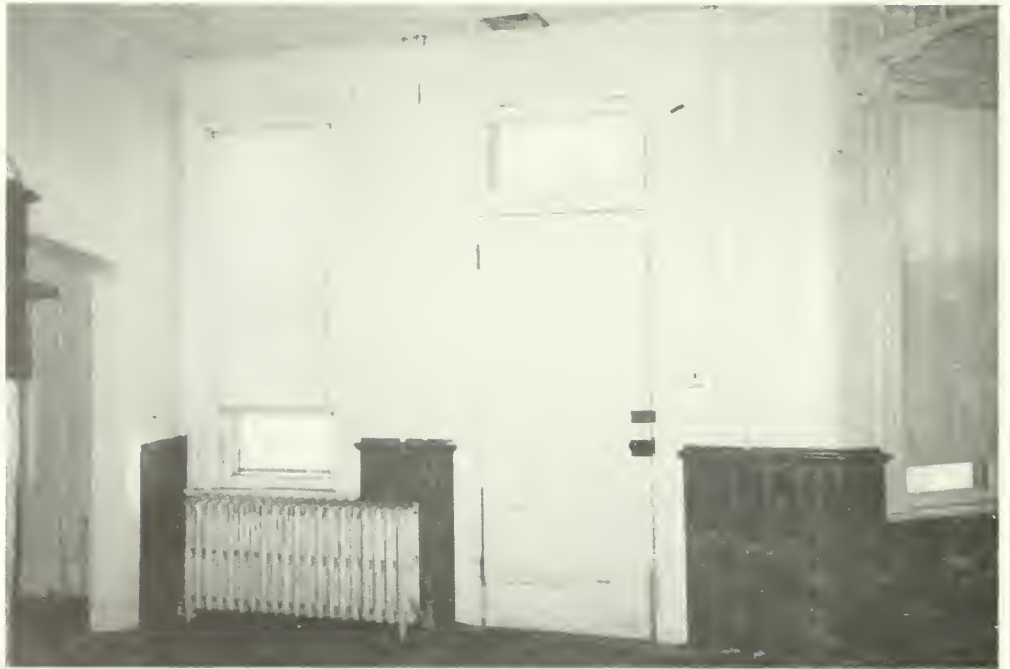
Photo E-41 North wall of room 106. Although the wood wainscot is original, the original entry door has been replaced.
Brown Cottage 1992

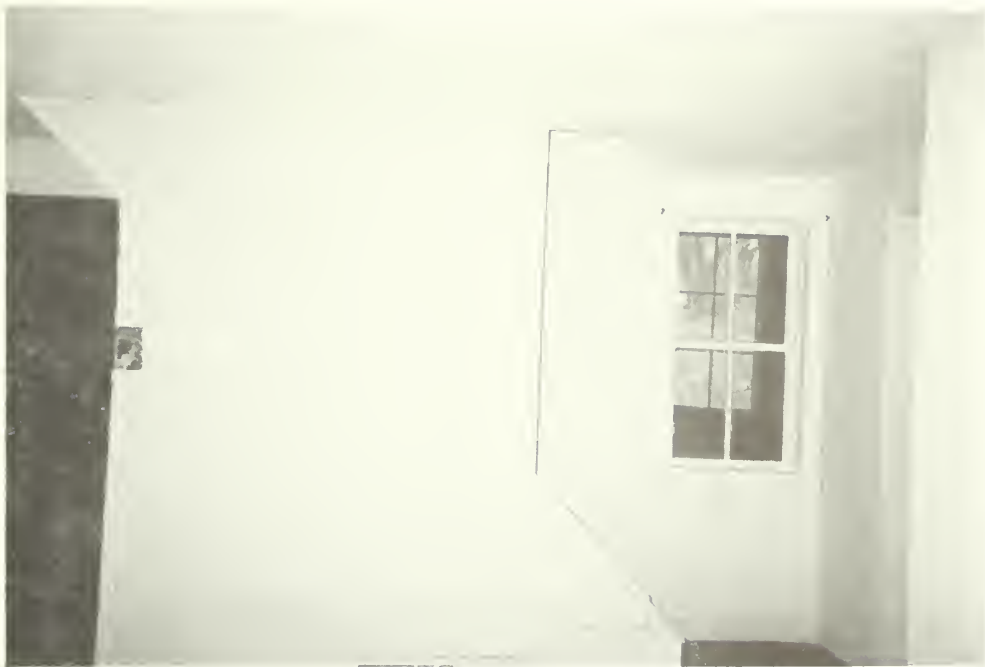
Photo E-79 South wall of room 106 showing paneling at stairway installed from another location. The window to the right of the stair replaces an original door. Moorhead Cottage 1992

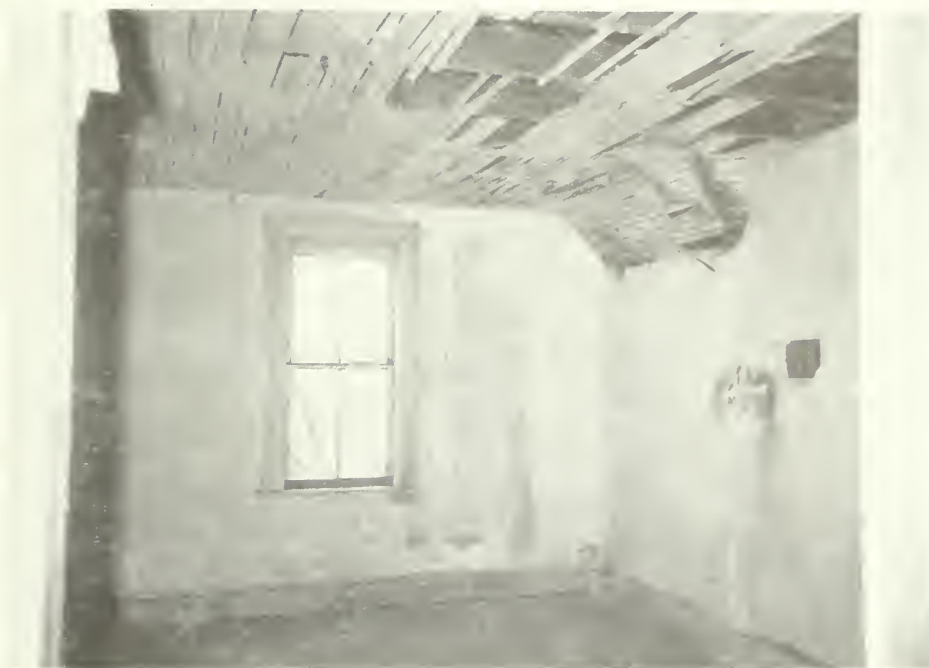
Photo E-90 Southeast corner of room 301, showing deteriorated wall and ceiling plaster.
Moorhead Cottage 1992

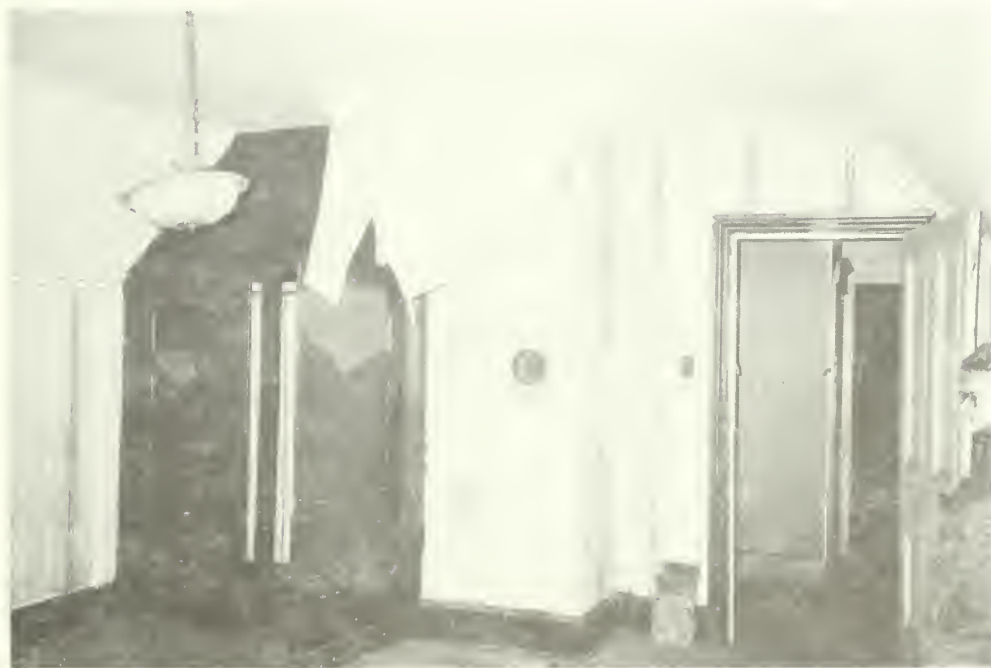
Photo E-91 South wall of room 304 with view to hall 300. Closet to the left is a later addition.
Moorhead Cottage 1992

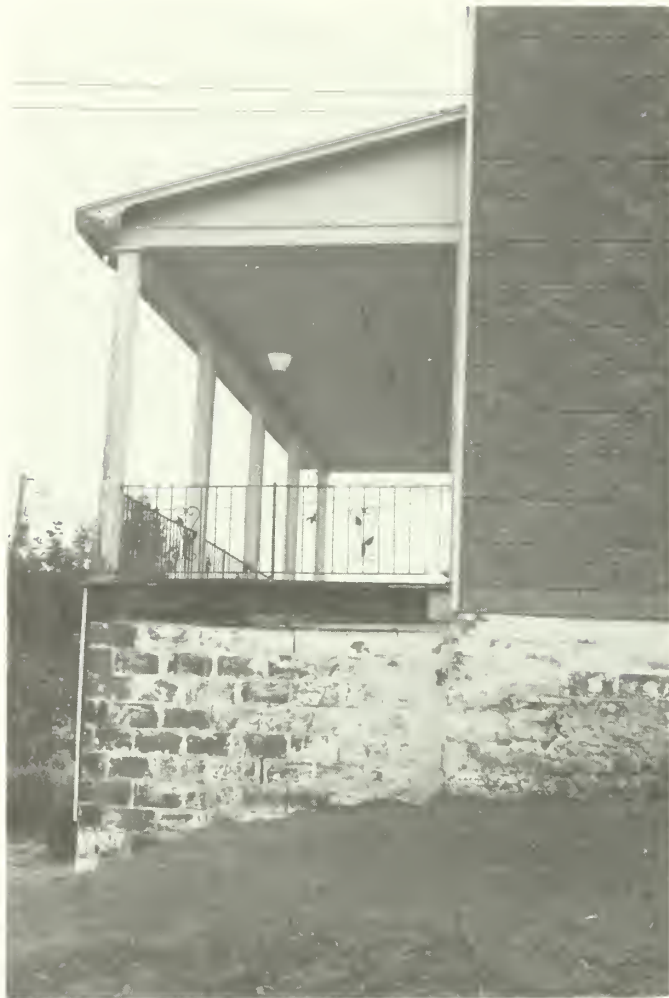
Photo E-97 Detail of the north foundation wall showing original stone foundation with brick and concrete block infill above.
Clubhouse Annex 1992
